2023 Data Report for

Horsehead Lake, Mecosta County

Site ID: 540085

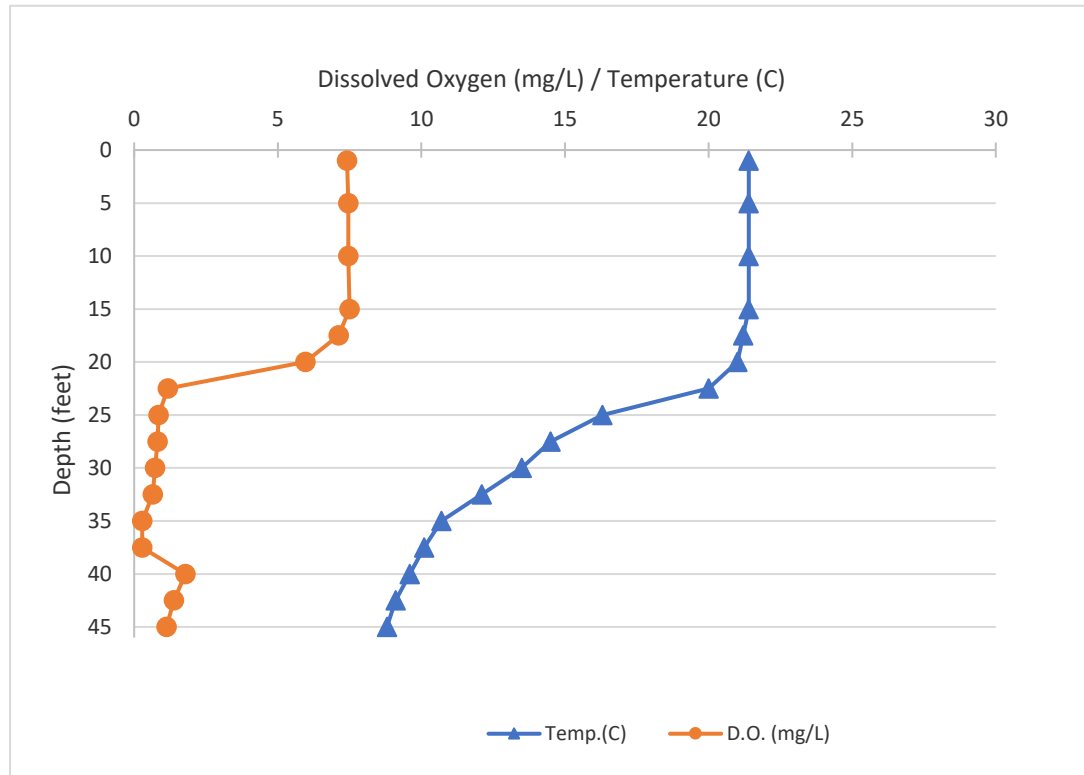
9/14/2023

Dissolved Oxygen and Temperature Profile
